your church tour

Church of  
St Michael

Farndish, Bedfordshire

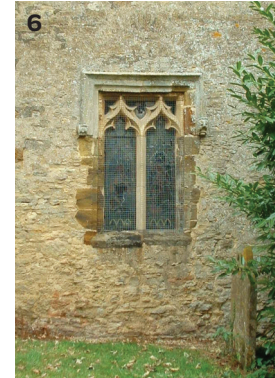
6 The **chancel south window** is in similar Decorated style but the carved heads appear to be reused Norman work. There is some contrasting stone. Left of this window two vertically-set stones mark the sides of a low-side window, used by the clergy to ring the sanctus bell at the culmination of the Mass. Such a 'saint bell' is recorded here in 1552 and 1822.
