## About St Michael's

# Church of St Michael and All Angels

Princetown, Devon

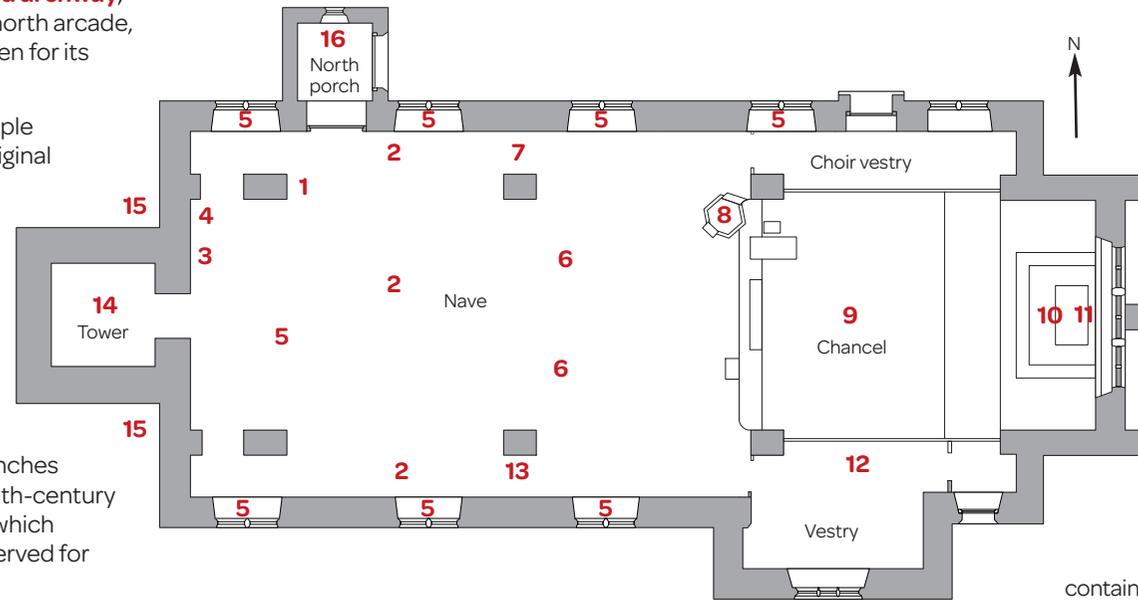
1 The **font** stands immediately within the doorway of the church, symbolising entrance to the Christian community through Baptism.

2 Looking across the church, notice the great width of the **nave** and the narrow **aisles**. These were created by the insertion of the **arcades**, with their tapering piers and chamfered double arches in 1908–10. The almond-shaped **internal windows** with open tracery above the arches are an unusual feature.

3 A 19th-century Gothic **altar table** stands against the west wall. This was supplanted by the present altar in the 20th century; redundant church furnishings like this often survive in churches and provide valuable evidence of changing tastes.

4 Above the altar table, traces of a **blocked archway**, partially obscured by the walling of the north arcade, reveal that the building was originally open for its entire width.

5 The **windows** of the nave, with their simple 'Y'-tracery, also survive from Walters' original building. The walls were originally higher, perhaps to allow headroom in the galleries, but were reduced to their present height during Sedding's alterations.

6 The **pews** or open **benches** are of an unusual type for Devon; they are typical of the Victorian fashion for 'honest' construction, with 'Y'-shaped bench ends and exposed joints. The benches probably date from R M Fulford's mid-19th-century restoration and replace earlier seating, which included some enclosed 'box pews' reserved for officers and their families.

7 In the north aisle is a large wall **monument** to Sir Thomas Tyrwhitt (1762–1833), founder of Princetown, its church, and its prison. The inscription states that: *'His name and memory are inseparable from all the great work on Dartmoor and cannot cease to be honoured in this district'*. The monument now stands behind one of the inserted arcade piers and is difficult to read.

8 The large late 17th- or early 18th-century **pulpit**, decorated with carvings of the four evangelists, was purchased from St Sidwell's Church in Exeter, at its rebuilding in 1814, and is a fine example of its type.

9 The **chancel** still retains furnishings designed by R M Fulford in the 1870s, including the frontals to the **choir stalls** and the **vicar's stall**. These were retained after the addition of the present chancel in 1908–10. Unfortunately, Fulford's **choir benches** were removed in the 20th century, though one survives, loose, in the vestry.

11 The **stained glass window** in the east wall of the chancel was installed in 1910; a gift from the 'National Society of United States Daughters of 1812', to commemorate the American prisoners of war held at Princetown between 1813 and 1815. The window was made by Mayer of Munich and depicts scenes from the Life of Christ (cover), culminating in his Passion, Resurrection and his Ascension in the central light of the window. It is now believed that 271 American prisoners died while in captivity at Dartmoor.

12 The two-manual **organ** was built by Frederick Tucker of Plymouth and is unfortunately now derelict. It is flanked by British, French and American flags, the former donated by HMS *Brilliant*, one of the ships involved in the Falkland Island Conflict, in 1982.

13 In the south aisle is a touching **wall monument** to three men of the 7th Royal Fusiliers, who perished in a snowstorm on the moor while *'braving the danger in preference to disobeying orders'*.

14 The **tower** is in 'Gothick' style typical of the Regency period, with arched windows containing 'Y'-tracery, quatrefoil windows below the belfry and obelisk pinnacles at the summit. The east wall still shows the scar of the original roofline of Walters' church, altered in 1908–10. The bells for the tower had been cast, but not installed, by the time of the closure of the prison in 1815; they were hung instead in the dockyard chapel at Plymouth.

15 The tower was originally flanked by a porch and a vestry on either side. Blocked granite **arches** serving these (and perhaps also gallery stairs) are visible on either side of the tower.

16 The present entrance and **north porch** date from the early 20th-century alterations.

10 At the east end of the chancel the earlier altar table (mentioned above) was replaced in the 20th century by an **'English altar'** enclosed by a **'dossal'** and **'riddells'** (rear and side curtains) supported by four **riddell posts**. This reflects late 19th- and 20th-century enthusiasm for late-medieval English liturgy and furnishings.
